<b>A1</b>	Trouble-shooting program	↓
-----------	--------------------------	---

## 1. Rapid diagnosis chart

Saab 99, Turbo; Saab 900, Turbo

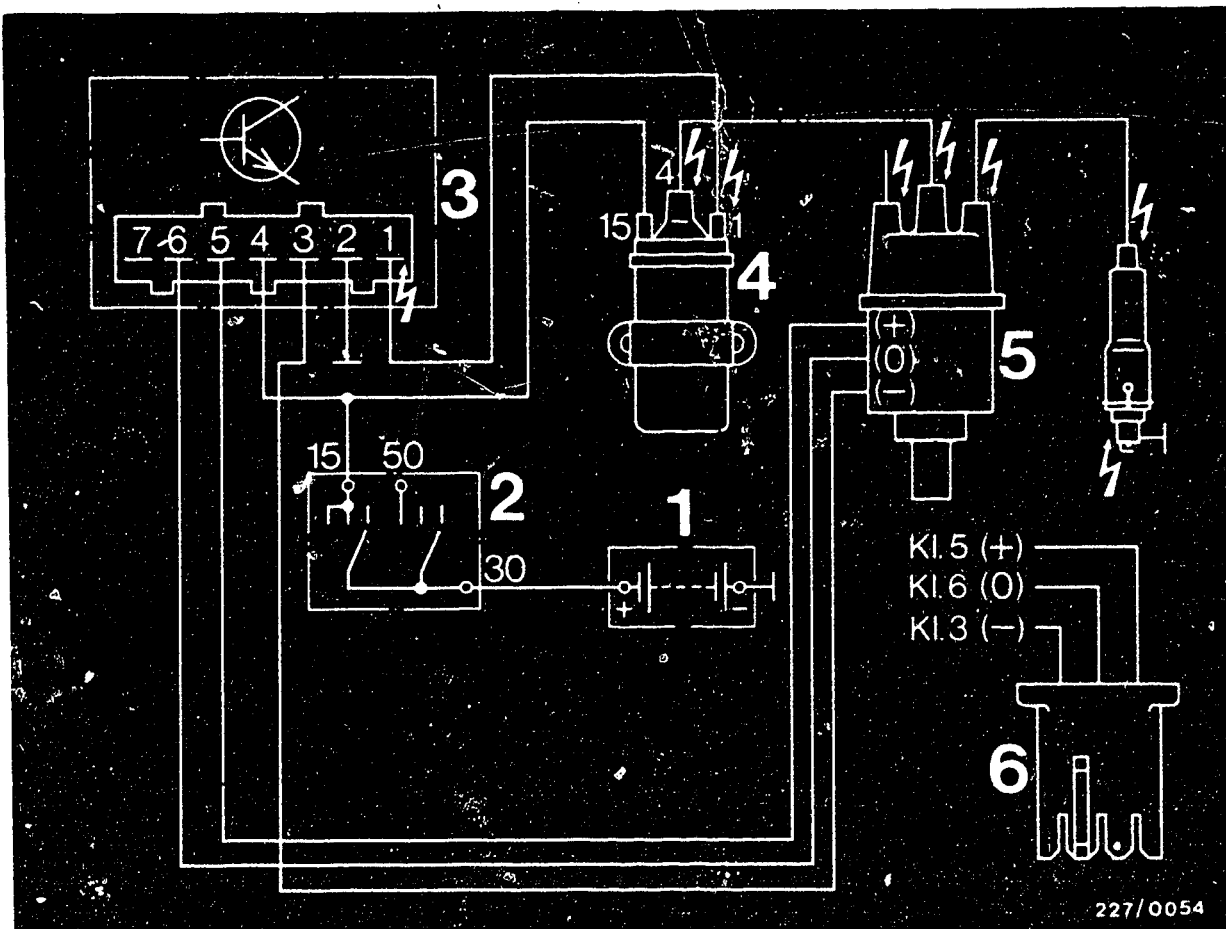
⚡ = Dangerous voltages (400 V - 25 kV)

- 1 = Battery
- 2 = Ignition and starting switch
- 3 = Trigger box (TCI-i)
- 4 = Ignition coil
- 5 = Ignition distributor
- 6 = Trigger box (ESV)

### 3. Electrical terminal diagram

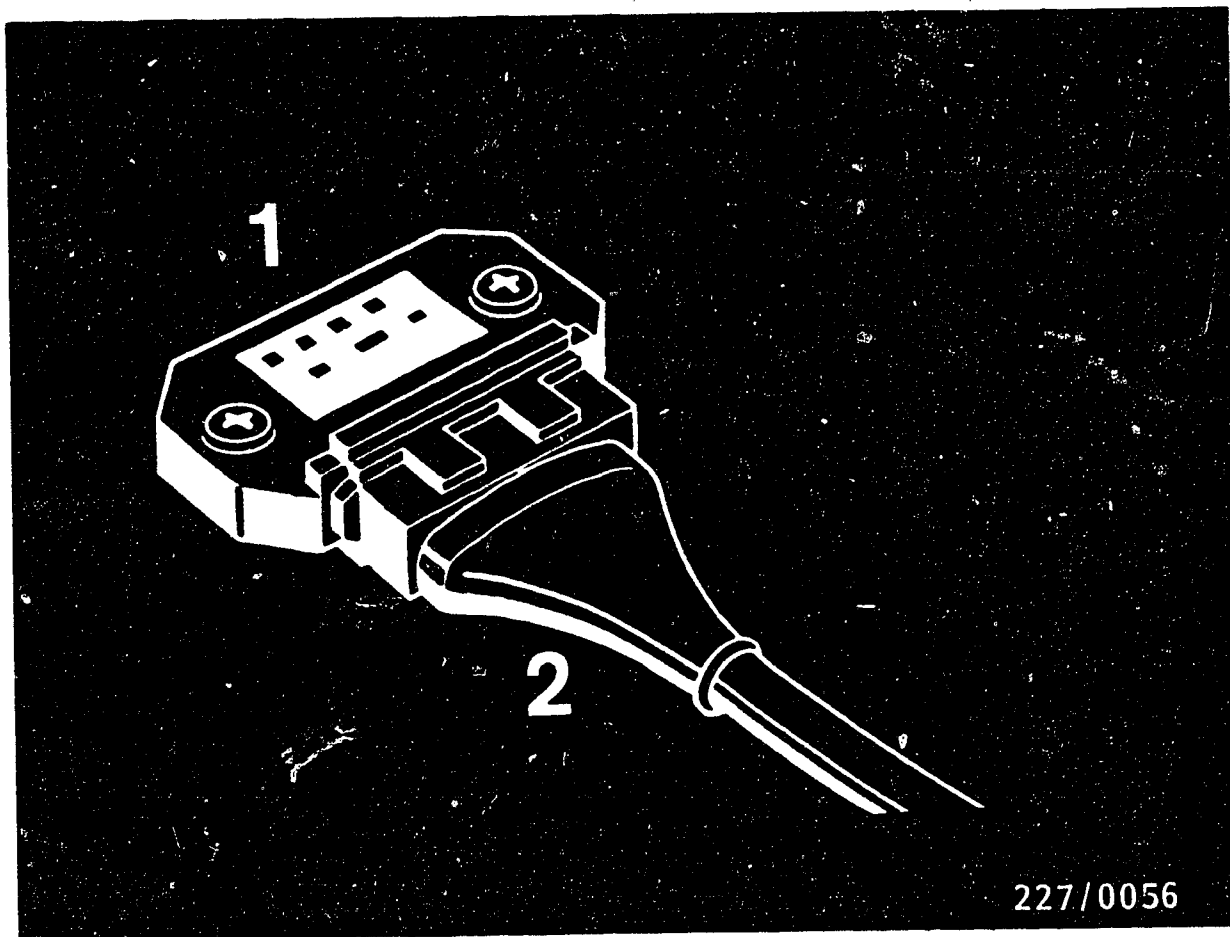
227/0056

- 1 = TCI-H trigger box  
2 = Trigger-box plug

#### 4. Installation location of the individual components

The trigger box is fitted to the left-hand vertical panel in the engine compartment (when seen looking over the hood from behind the steering wheel).

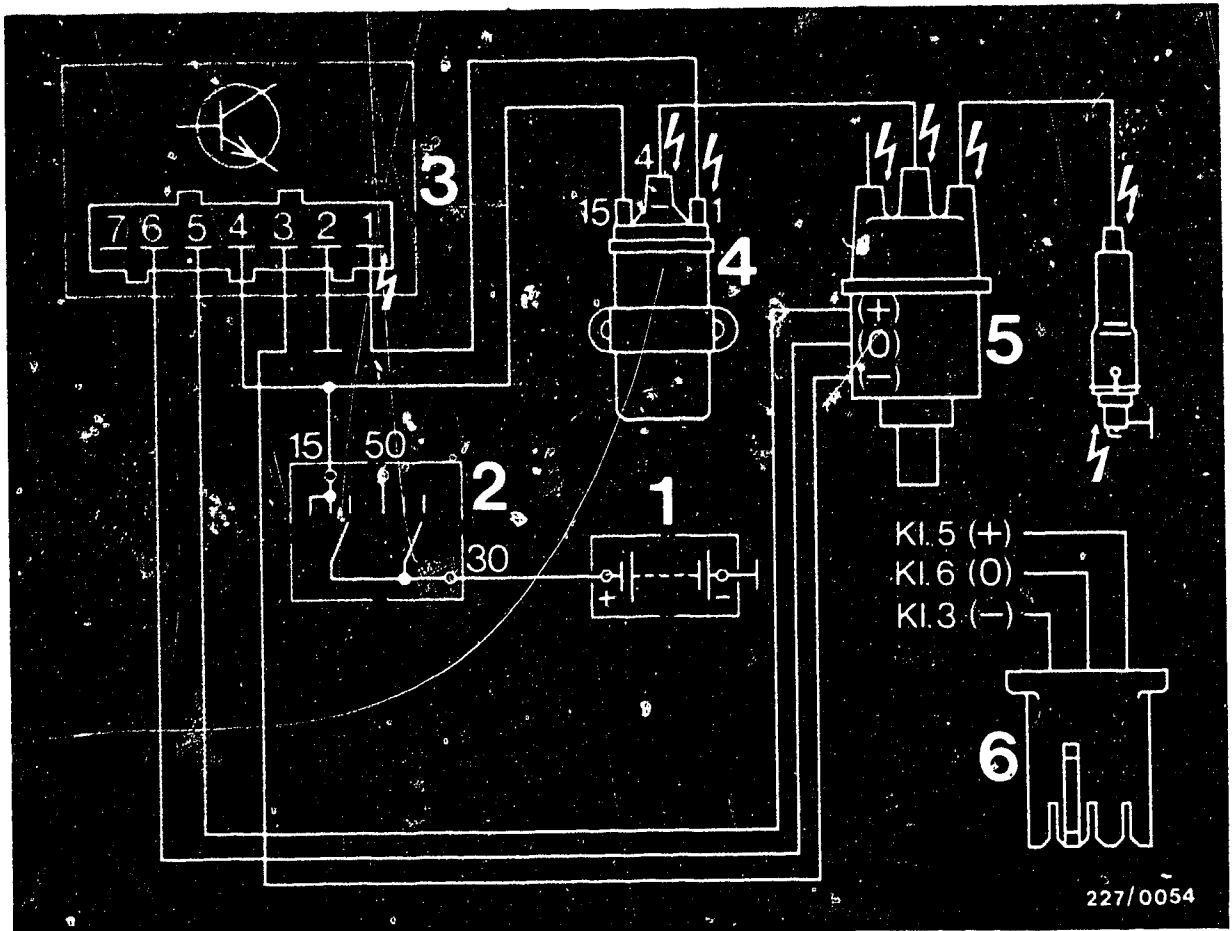
KI. = Terminal

- 1 = Battery
- 2 = Ignition and starting switch
- 3 = Trigger box
- 4 = Ignition coil
- 5 = Ignition distributor
- 6 = Ignition distributor connector

= Dangerous voltages (400 V - 25 kV)

### Electrical terminal diagram

The dangerous locations are marked with danger arrows taking the example of the terminal diagram of an electronic ignition system.

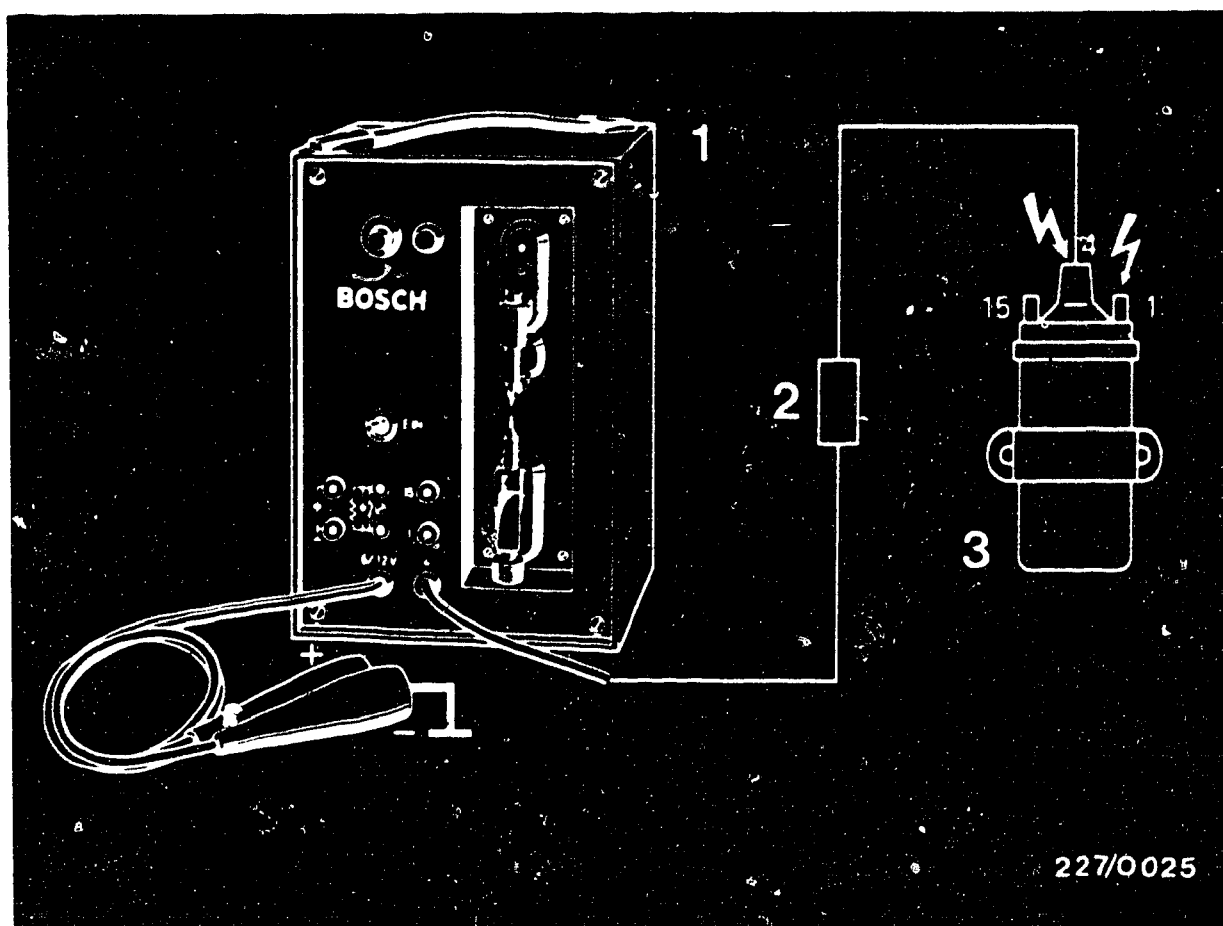
227/0025

- 1 = Spark gap
- 2 = 5 kΩ sleeve-type suppressor
- 3 = Ignition coil

- In order to prevent the trigger box from being irreparably damaged, when using a spark gap, an interference-suppression resistor of at least 2 kΩ must be connected between the spark gap and ignition coil terminal 4, e.g. sleeve-type suppressor (5 kΩ) 0 356 500 001.
- In the case of ignition distributors with engine-speed limitation the ignition distributor side terminal 4 must have 1 kΩ interference suppression. Operation without interference suppression will lead to the destruction of the trigger box.

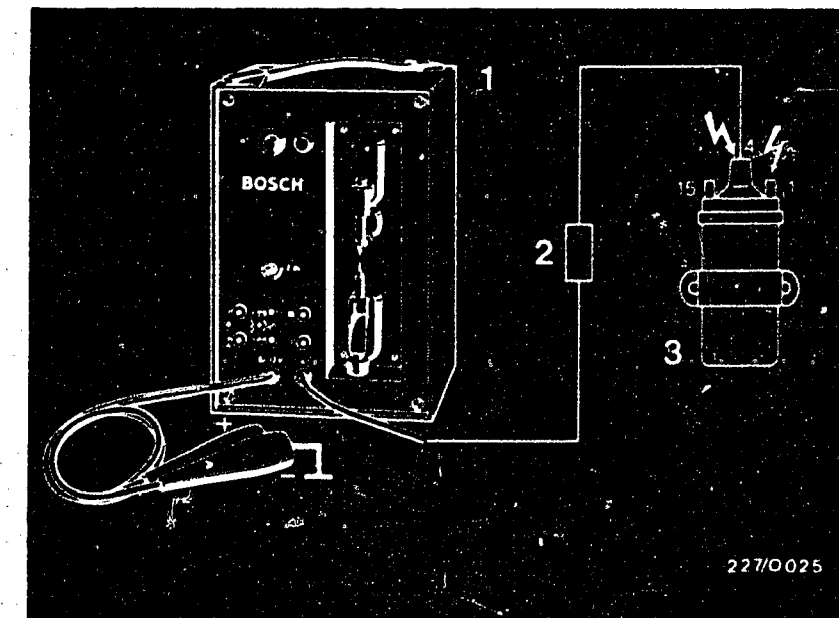
- 1 = Spark gap
- 2 = 5 k $\Omega$  sleeve-type suppressor
- 3 = Ignition coil

⚡ = Dangerous voltages (400 V - 25 kV)

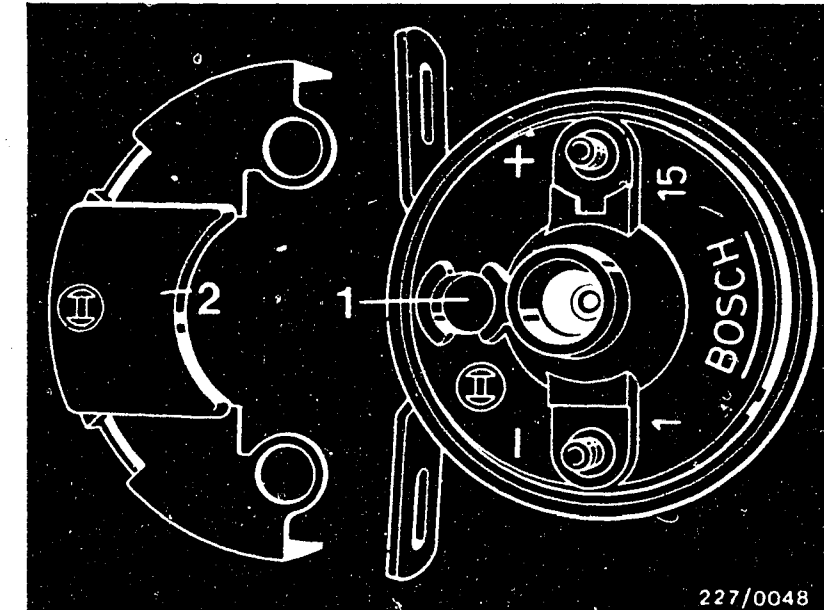
**B5**

1 = Plug  
2 = Protective cap

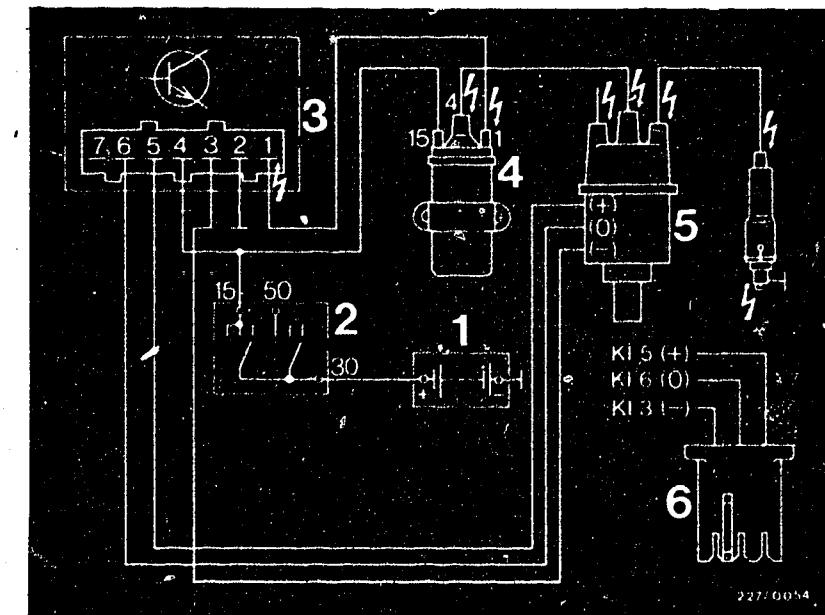
**B7**

- 1 = Battery
- 2 = Ignition and starting switch
- 3 = Trigger box
- 4 = Ignition coil
- 5 = Ignition distributor
- 6 = Ignition distributor connector
- ⚡ = Dangerous voltages (400 V - 25 kV)

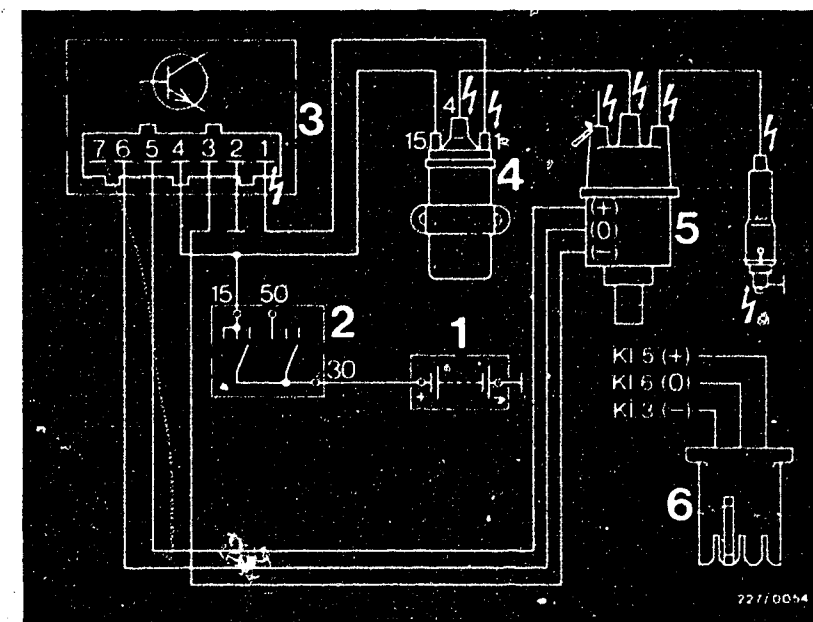
- 1 = Battery
- 2 = Ignition and starting switch
- 3 = Trigger box
- 4 = Ignition coil
- 5 = Ignition distributor
- 6 = Ignition distributor connector

⚡ = Dangerous voltages  
(400 V - 25 kV)

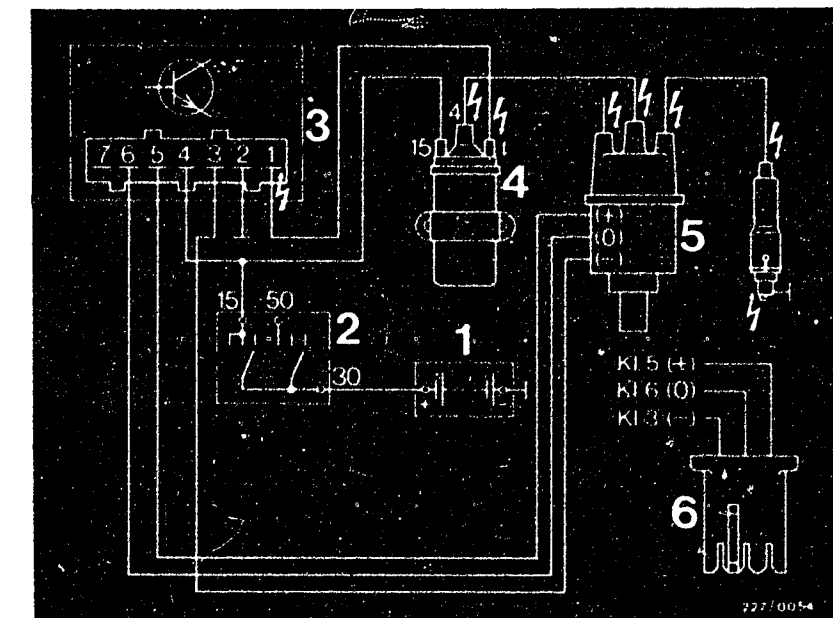
- 1 = Battery
- 2 = Ignition and starting switch
- 3 = Trigger box
- 4 = Ignition coil
- 5 = Ignition distributor
- 6 = Ignition distributor connector

⚡ = Dangerous voltages  
(400 V - 25 kV)

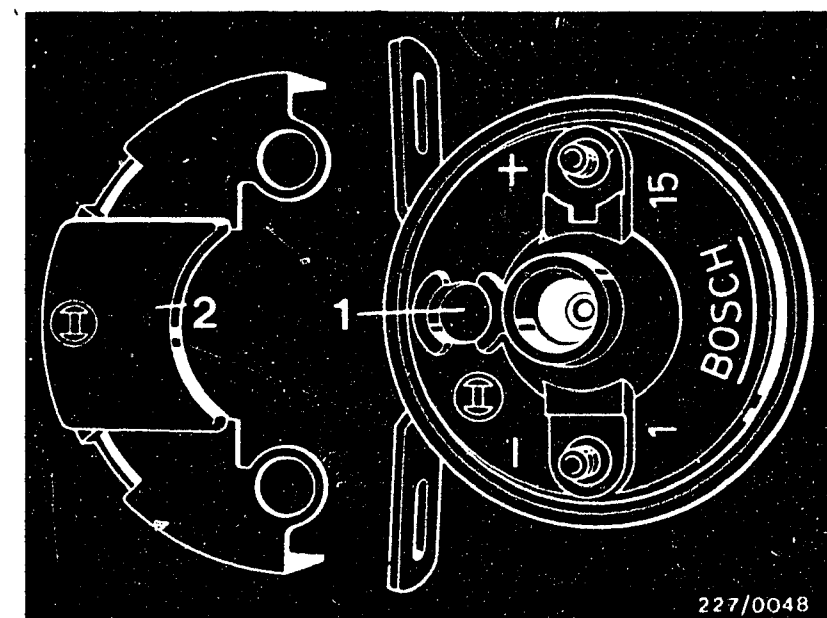
1. If plug is not in position and/or sealing compound has escaped, replace trigger box and ignition coil.

2. If resistance values are not O.K., replace ignition coil.

1 = Plug

2 = Protective cap

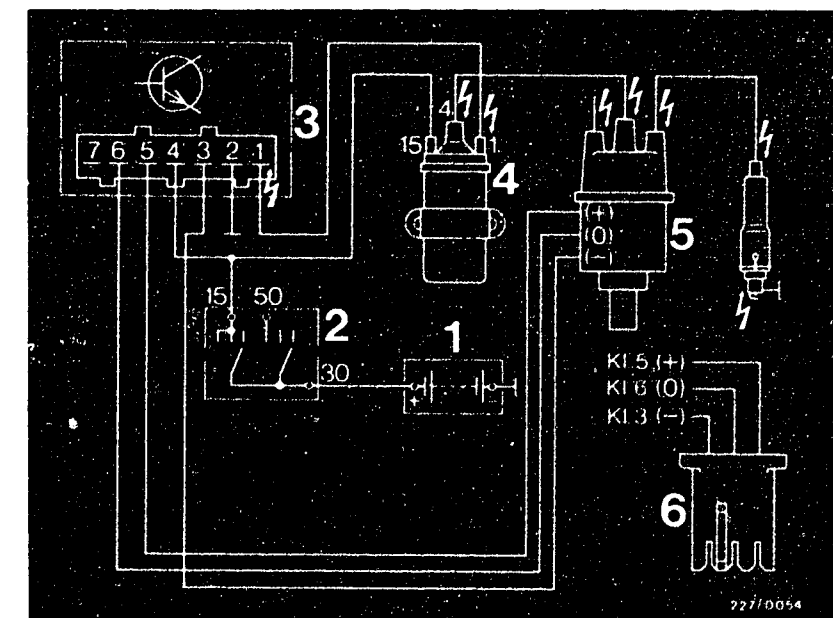
- 1 = Battery
- 2 = Ignition and starting switch
- 3 = Trigger box
- 4 = Ignition coil
- 5 = Ignition distributor
- 6 = Ignition distributor connector

⚡ = Dangerous voltages  
 (400 V - 25 kV)

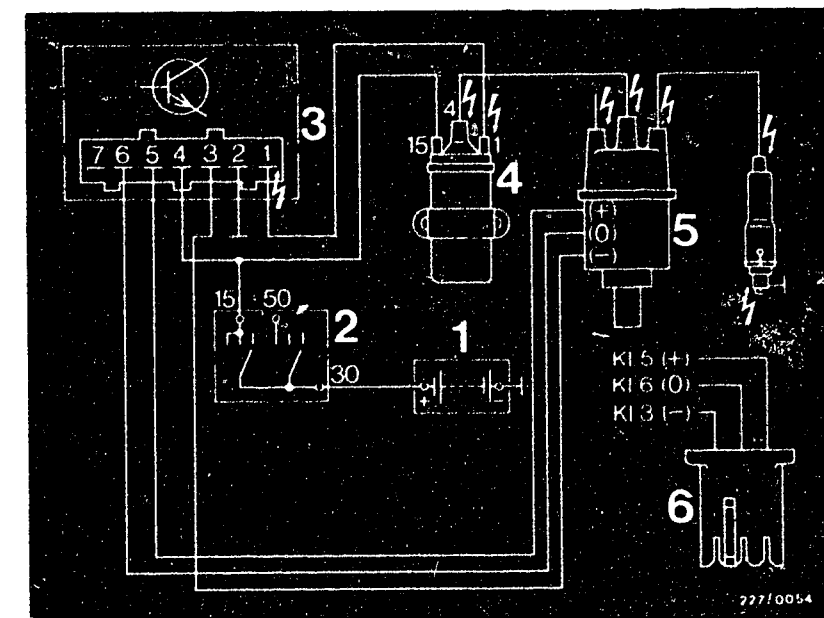
- 1 = Battery
- 2 = Ignition and starting switch
- 3 = Trigger box
- 4 = Ignition coil
- 5 = Ignition distributor
- 6 = Ignition distributor connector
- ⚡ = Dangerous voltages (400 V - 25 kV)

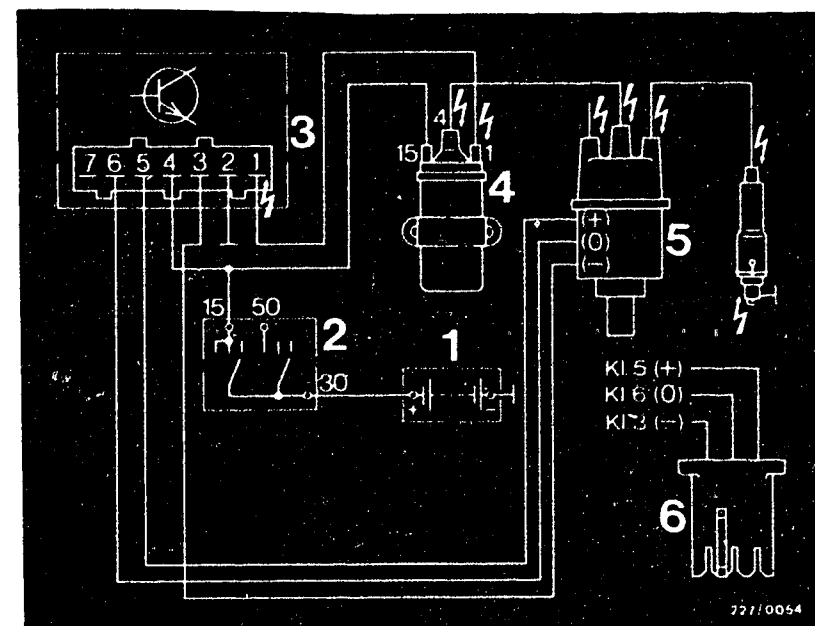
- 1 = Battery
- 2 = Ignition and starting switch
- 3 = Trigger box
- 4 = Ignition coil
- 5 = Ignition distributor
- 6 = Ignition distributor connector

⚡ = Dangerous voltages (400 V - 25 kV)

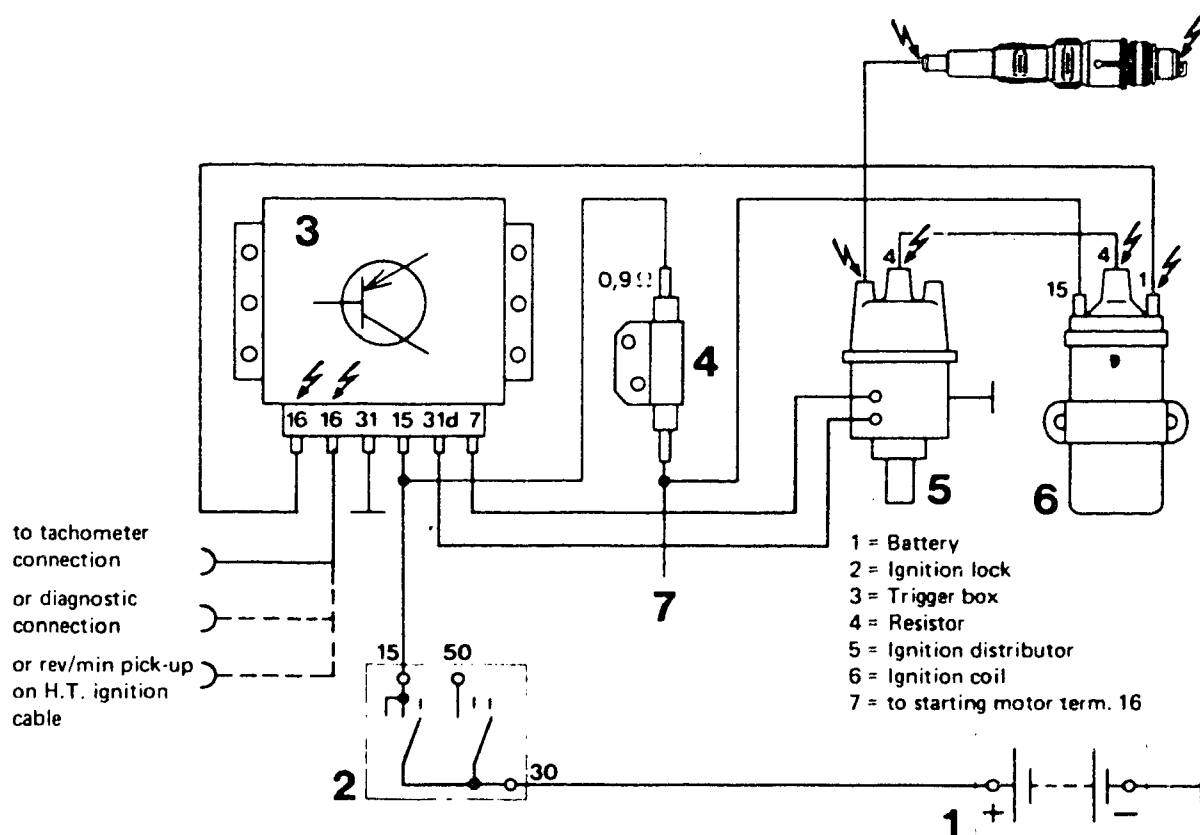
Terminal diagram

Below is a typical terminal diagram of a semi-conductor ignition system, the danger points are marked with red high-voltage arrows. We would point out that all semi-conductor ignition systems, even the older ones, are to be regarded as dangerous in the sense as defined by this bulletin.

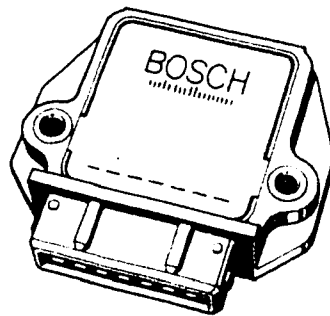
Fig. 1

Hybrid construction trigger boxes  
0 227 100 100 for ignition distributor  
with Hall generator (TCI-h)  
0 227 100 102 for ignition distributor  
with induction-type  
pulse generator (TCI-i)

Apart from the well-known TCI trigger boxes 0 227 100 0.., trigger boxes of hybrid construction have been fitted as standard since 9.78 (Fig. 1).

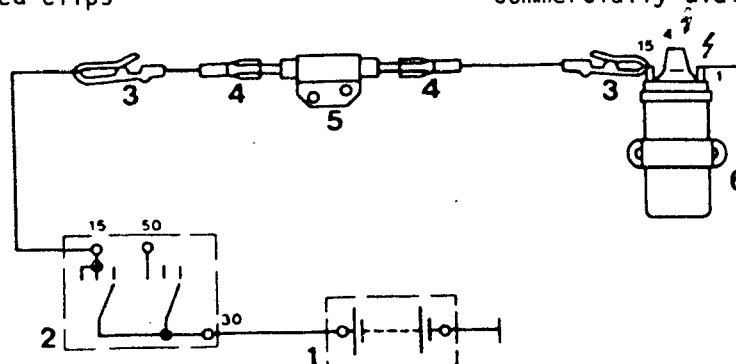
Connect a ballast resistor of 0.9 or 1.0 Ohm (see Fig.) in series in the line to term. 15 of the ignition coil (take care not to cause a short circuit). After the rotational-speed measurement, the ballast resistor must be removed (otherwise starting difficulties and misfiring). Connect tester as per operating instructions.

1 = Battery

2 = Ignition switch.

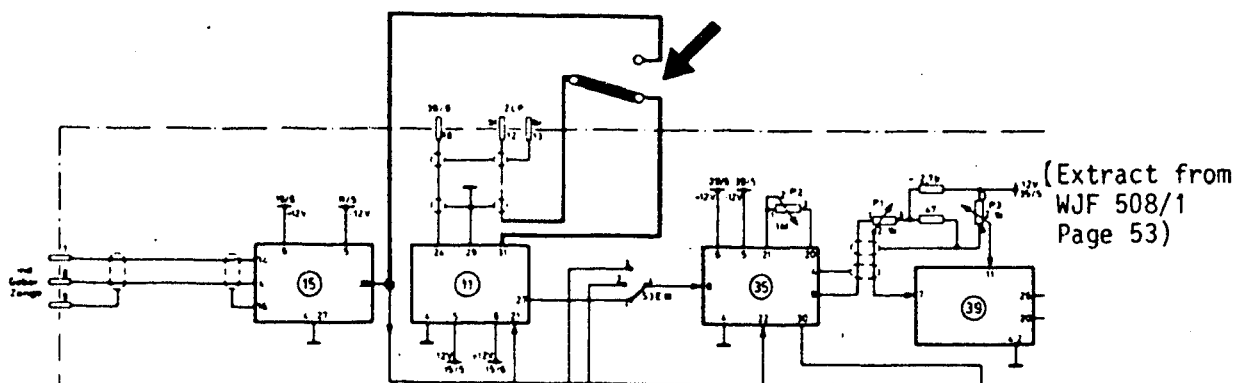
Remove the line of the ZLP\* from pin 31 of printed board 11 (coupling stage) and connect to pin 30 of printed board 15 (pulse shaper stage) via a switch with change-over contact (e.g. 0 341 500 803). In addition, a new line must be connected from pin 31 of printed board 11 to the other contact of the switch with change-over contact. Arrow points to switch with change-over contact.

\* ZLP = timing light

ind. Geber-Zange = Clamp-on induction pickup

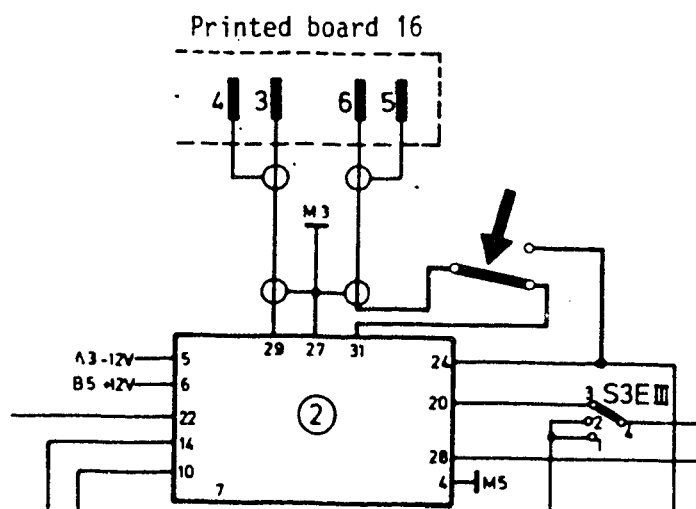
#### EFAW 214 B

Remove the line from terminal 6 of printed board 16 to pin 31 of printed board 2 (coupling stage) and connect to pin 24 of the same printed board via a switch with change-over contact (e.g. 0 341 500 803). In addition, a new line must be connected from pin 31 of printed board 2 to the other contact of the switch with change-over contact. Arrow points to switch with change-over contact.

By fitting the switch with change-over contact in the front panel of the motor-tester, it is possible to switch over from standard ignition systems to those with current limitation. We recommend that the switch positions be marked correspondingly: e.g. "standard" - "current limitation". These conversion measures have already been published in the K7 information sheet KJF 28/7911.
